INFRARED TECHNOLOGY FOR PRESERVATION

Phillip C. McMullan

Thermo-Scan Inspections, Carmel, Indiana

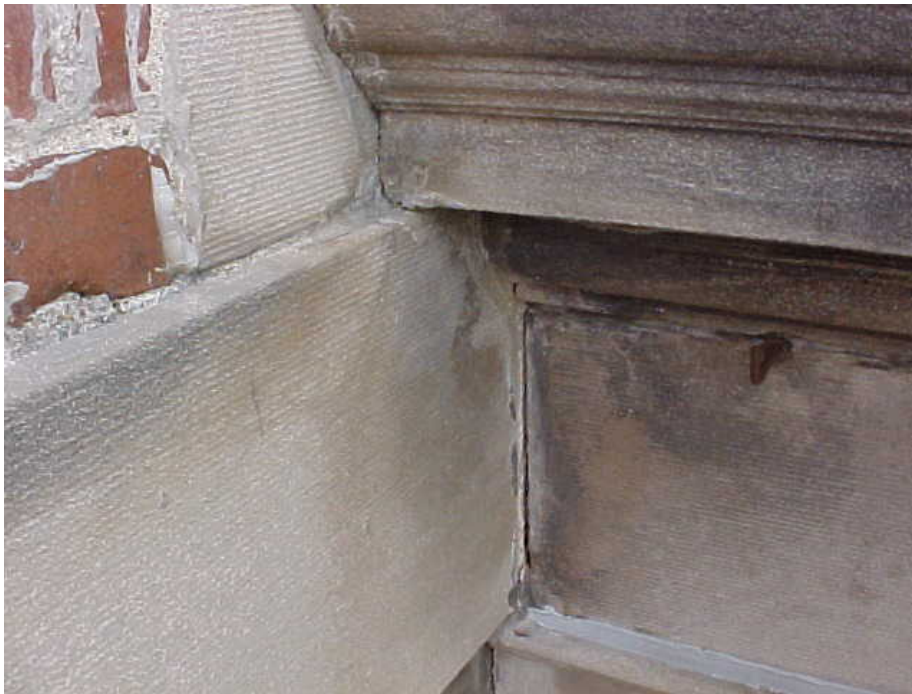
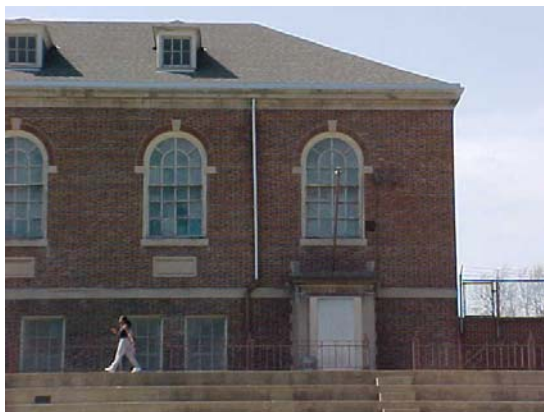
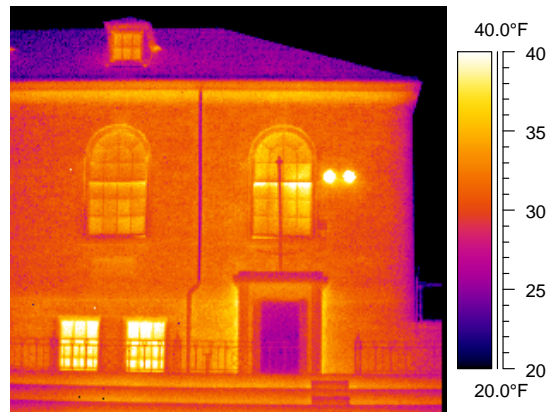
Figure 2. Location 1, Building K, east elevation.

1. Locations 1 and 2 are at the north and south entry doors on the east elevation. At these locations, along with the center two doors (all four east elevation entry doors), the thermal pattern indicated heat loss. Moisture testing produced the highest levels of hydrogen found in any of the elevations. Further investigation (see Figure 2 and 3 details) shows flashing and caulking failures at these entries.

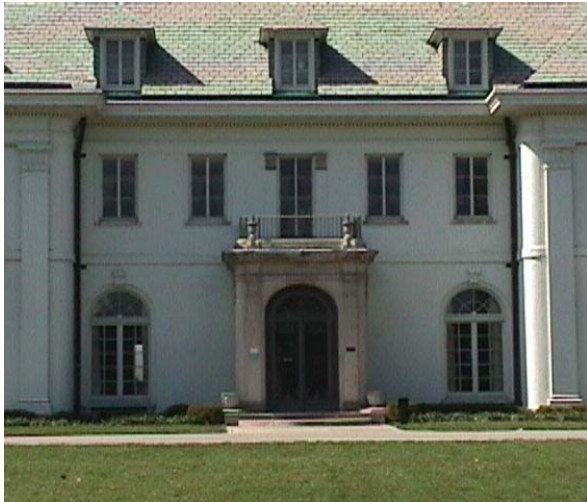
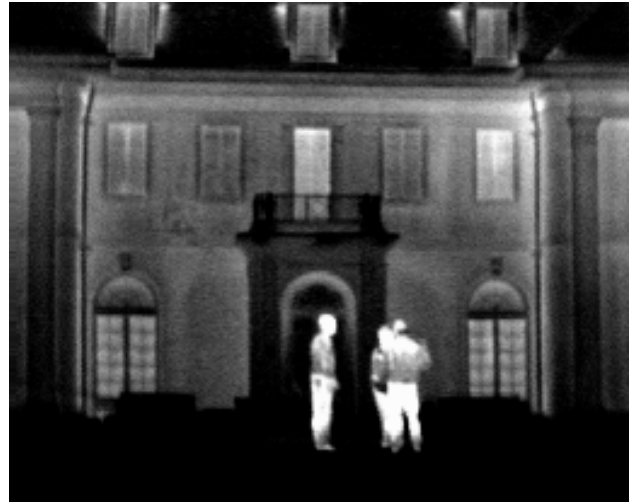
1. Heat loss at all windows. The windows represented the warmest of all exterior surfaces. Given the "R" value associated with windows compared to the walls of the building, this would be expected. Additional loss at the windows was seen around some window frames where lesser insulation values are necessitated by the framing for the windows and/or the frame around the window sash is exfiltrating warm air from inside the building.
2. Heat loss through walls. Based on information provided at the time of the inspection, the walls are uninsulated solid concrete or hollow clay tile block construction depending on location. This

3. Heat loss into attics. A common problem to both elevations inspected was heat escaping from the conditioned building envelope into the unconditioned attics. The infrared images confirm these patterns with heat escaping from the soffit areas, around dormers and the presence of an even warm temperature throughout the roof surface.

Figure 3. Oldfields Estate, front (east) elevation. The black and white thermograph (right) shows heat loss through windows and dormers. The human figures appear warmer than the building.
