# Lightning arresters' effect on power line reliability

Richard Strmiska

Sumter Electric Cooperative, Inc., P.O. Box 301, Sumterville, Florida 33585-0301

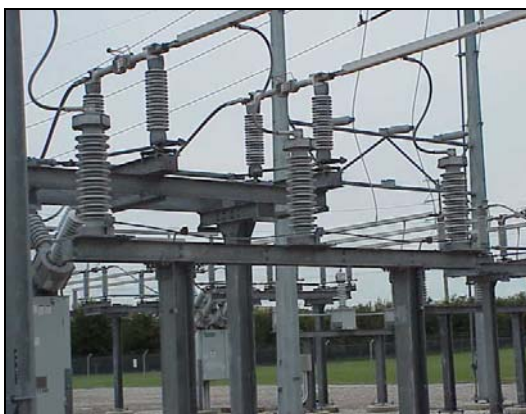
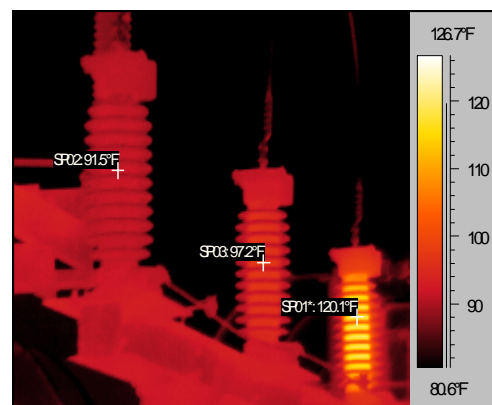
**Figure 1.** Failure of a 69 kV lightning arrester. This problem could have affected reliability of this power system by causing an outage to several thousands of consumers being served by this substation.

These types of lightning arresters are used in substations to protect the station and equipment from incoming surges due to lightning and almost any type of fault current. The data in the picture show the elevated temperature of the hot arrester in question. Failure of this type of arrester could affect a large number of consumers due to the size of these substations and where they are located. The picture below is an example of a hot 69 kV MOV arrester.

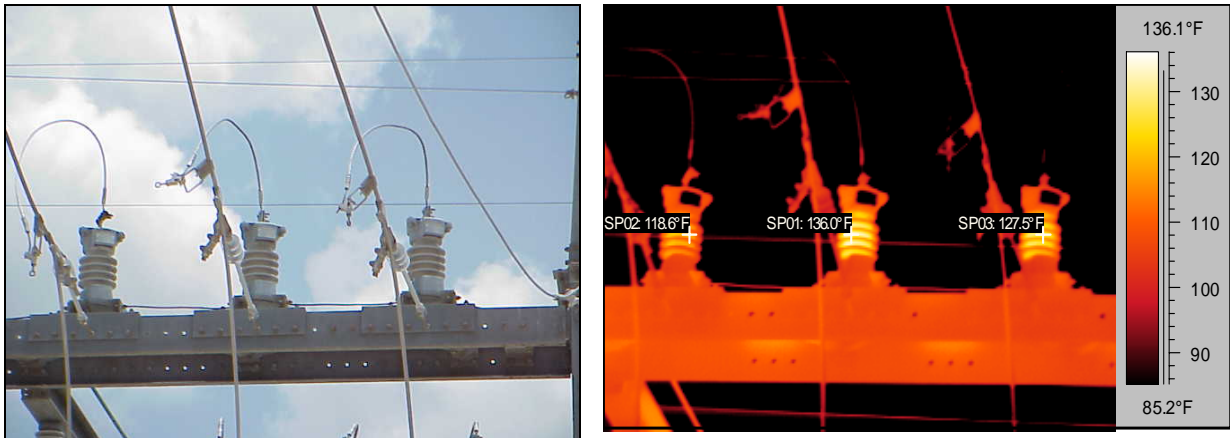
**Figure 2.** The heating problem with these arresters could have affected the reliability of this three phase feeder line. Feeder lines such as these serve 2,550 consumers.

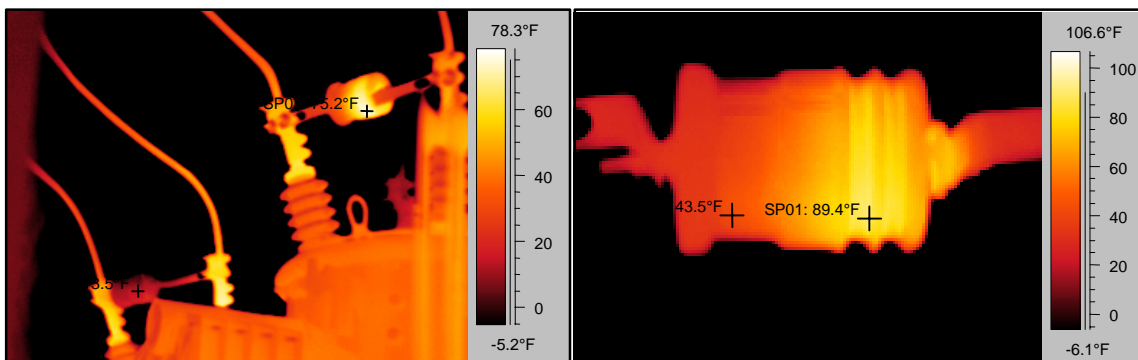
**Figure 3.** This problem arrester on the voltage regulator upon failure could have affected the reliability of the regulator and/or the total substation. This substation serves a total of 2,120 consumers.

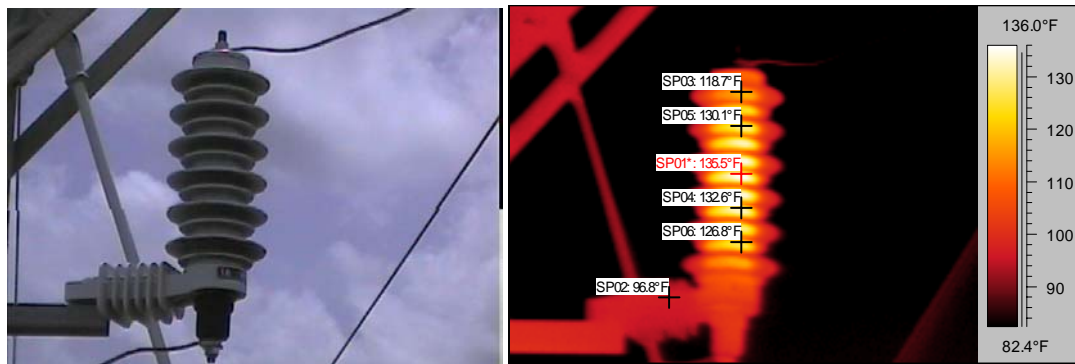
This 18 kV type lightning arrester, along with the 9 kV lightning arrester, has affected the reliability of our distribution system the most. The buildup of heat due to internal moisture or block failure enables the arrester to dump high amperage to ground if the isolator does not blow causing the substation breaker to relay the distribution line which now has affected reliability of power to the consumers.

**Figure 4.** The infrared thermogram shows a high amount of heat present within the arrester, thus causing the feeder to relay open. This also holds true for fused taps. The next page shows examples of the tests on returned lightning arresters that showed un hot on the distribution lines.

All intact stacks were heated in an oven at 120°C for 36 hours to drive out potential absorbed moisture. The measurements before and after treatment are listed in Table 1. The conclusion was that water ingress decreases the resistance of the arresters, allowing more current to flow, causing heating, as illustrated in Fig. 4.

In order to maintain the reliability of a power line transmission and distribution system, it is important to be able to identify hot lightning arresters with an infrared thermal imaging camera. Hot arresters should be removed and replaced in a timely manner to avoid costly outages.
